HERITAGE CASE STUDY

ANDERSON STUART BUILDING

University of Sydney | Camperdown, NSW

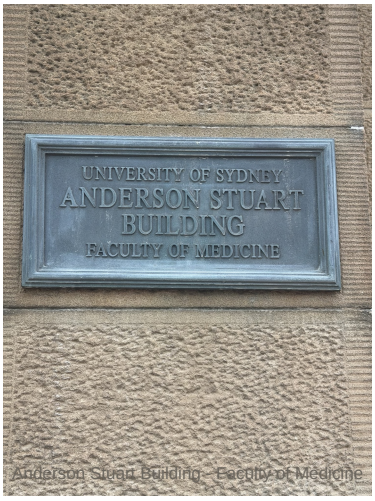
MAIN ENTRY FACADE - SCAFFOLD ACCESS

Heritage remediation and conservation works in progress.
